NEW AGAIN

Pool-turned-patio project works

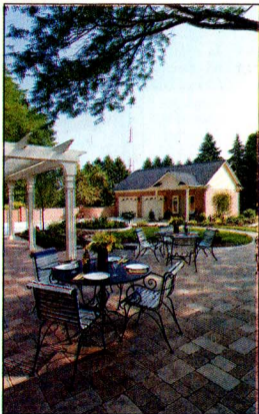
An old pool, above, was replaced with a patio. The project required filling the hole with a mixture of K-Crete, sand, cement and water.

Landis filled the pool with 180 cubic yards (20 mixer-truck loads) of K-Crete, a mixture of sand, cement and water. Filling the pool required two days. The mixture became firm in two days and was set in three weeks.
